HYDRAULIC AND STRUCTURAL ASSESSMENT OF THE RAVI SYPHON STRUCTURE FOR UP GRADATION

ABSTRACT

Inspection Results of Ravi Syphon Structure (Five Barrels)

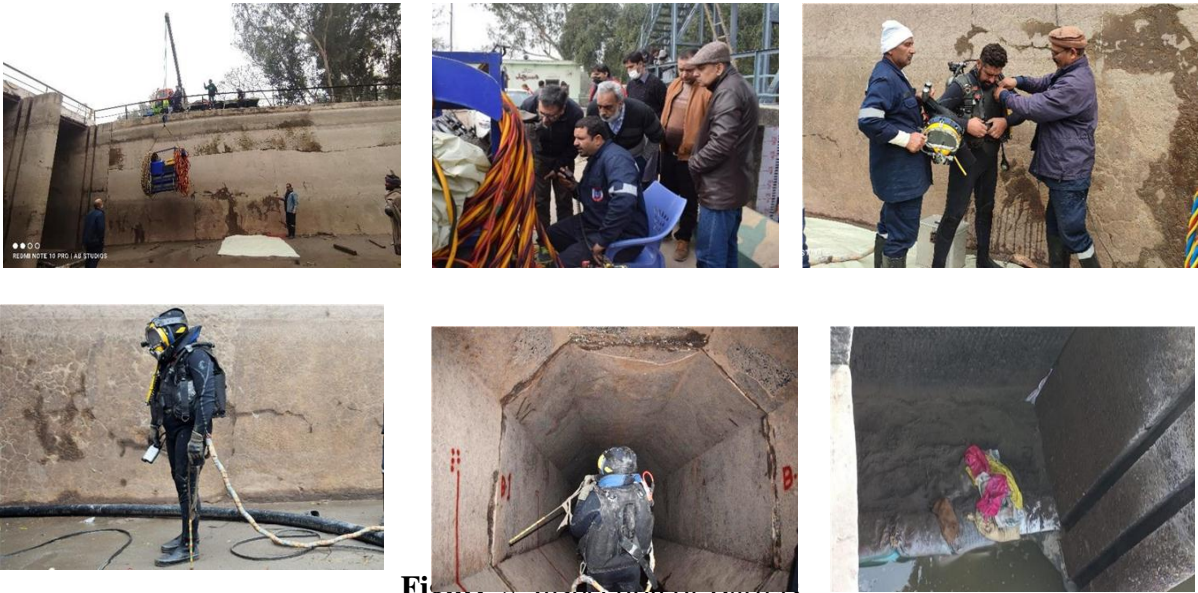
Figure 2: Inspection of Dams

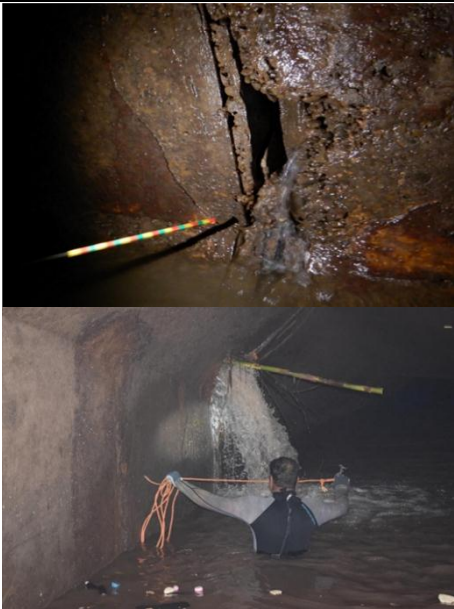
- ii. A huge opening of size 1.5 ft x 1.5 ft has been developed in the joint at the transition of sloping and straight portions of the barrel. Heavy flow of water through this opening prevented complete dewatering of barrel even after continuous operation of pumps.

Figure 3: River flow through damaged and concrete at joint with leakage

Figure 4: Removal of joint filling wall in Barrel No. 1

246 the base. The proposed thickness of sprayed concrete is 2 inches (50 mm) and that of
247 reinforced concrete is 4 inches (100 mm). Repairing of the damaged upstream bed
248 protection is essential and proposed that scour holes should be rock filled. This
249 treatment of syphon structure will enhance the capacity and will also increase the life
250 of structure for almost 30 years.

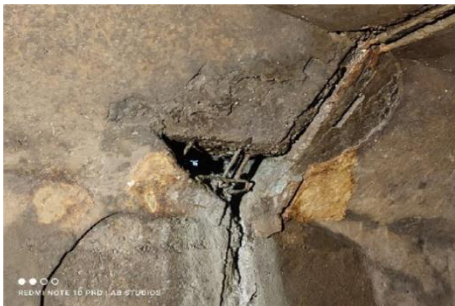
- v. At some places, steel reinforcing steel bars are exposed and are subjected to rusting and corrosion.
- vi. Most of the joints are in deteriorated condition and the joint filling of water proofing material has been removed. Concrete has lost its strength at such locations and steel reinforcement is exposed.

Figure 5: Damaged wall in Barrel No. 1 in Dry Condition (steel exposed)

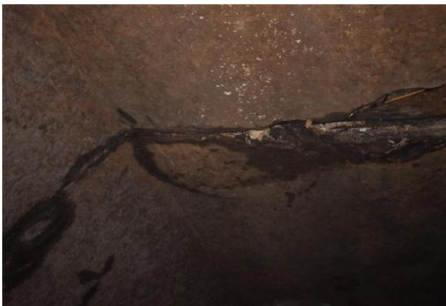
Figure 6: Leaking Joint with removed filling

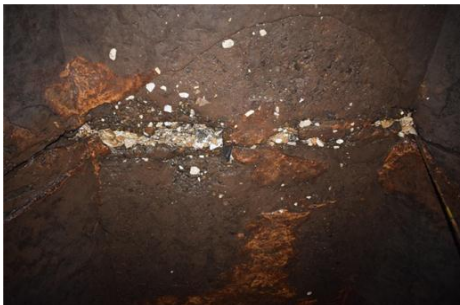
Figure 7: Rusting of Steel at Joint Location

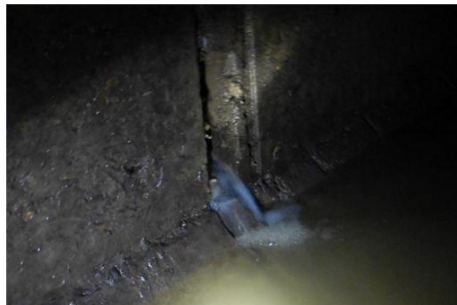
- 194 iii. Bulging/ spalling of a significant patch of surface concrete has been observed which
195 indicates excessive deterioration of the concrete.
- 196 iv. Some significant openings/ holes at joint locations have been noticed which may be
197 attributed to removal of joint filling due to excessive abrasion. One such opening has
198 been observed in the mid portion by the diver through which water is freely flowing
199 between Barrel No. 4 & 5.

Figure 8: Opening of Joint with appreciable leakage between the Barrels 4 and 5

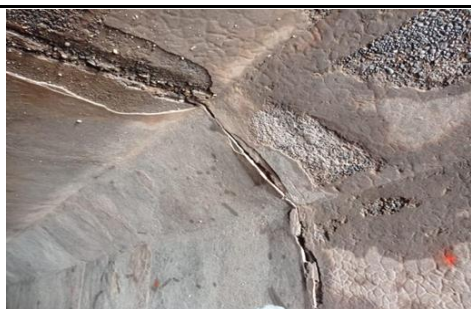
Figure 9: Deteriorated joint

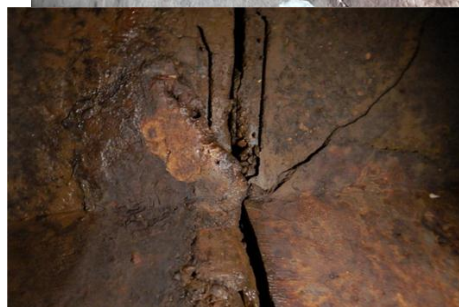
Figure 10: Deteriorated joint with seepage marks

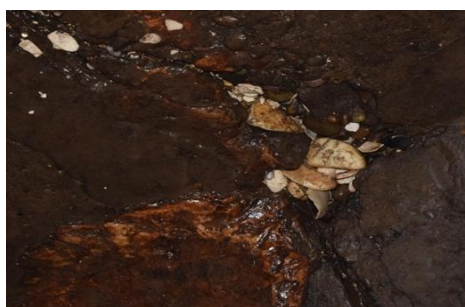
Figure 11: Chipping of Concrete and Corroded Steel

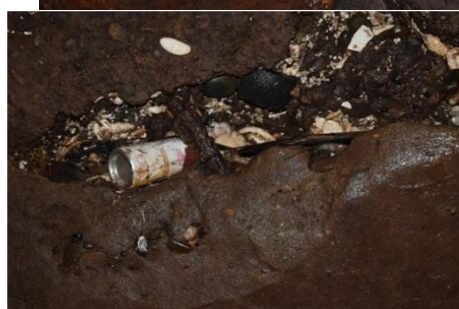
Figure 12: Leakage of Roof at Joint
